# Troubleshooting

## Troubleshooting the OP-640 Panel

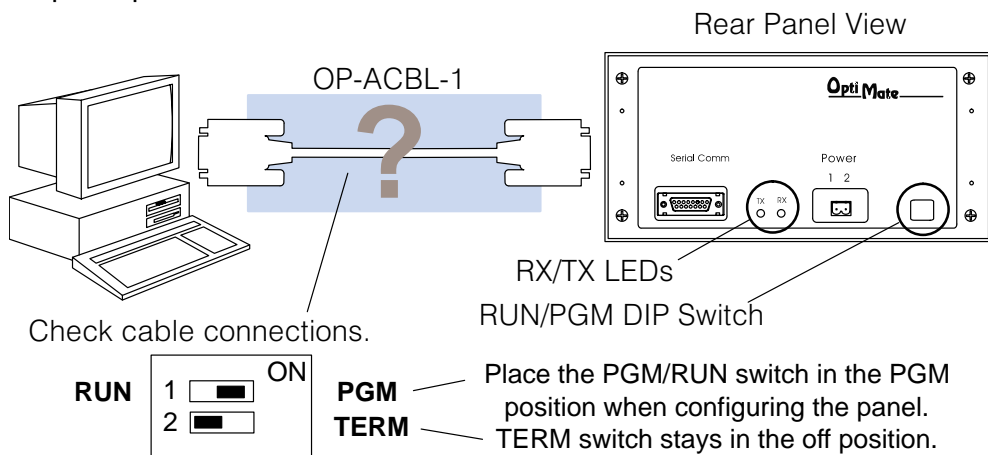
1. Check the rear panel RX/TX LEDs while attempting the Upload or Download operation. Both LEDs should be giving slow alternating flash signals, indicating the PC and OP-panel are connected. If *only* the TX (transmitter) LED is flashing, or if the TX/RX LEDs are *not* alternating between flashes, check that the OP-panel is set to the configuration mode by setting the RUN/PGM DIP switch to the PGM position.
2. Check to make sure the configuration cable (**OP-ACBL-1**) is properly connected.
3. Make sure the correct communications port is selected with the software, such as COM1, COM2, COM3, COM4.
4. Check the 24VDC power source and connections.
5. Make sure that **DirectSOFT** programming software is not running.
6. After checking the above items, repeat the online panel Download or Upload procedure.

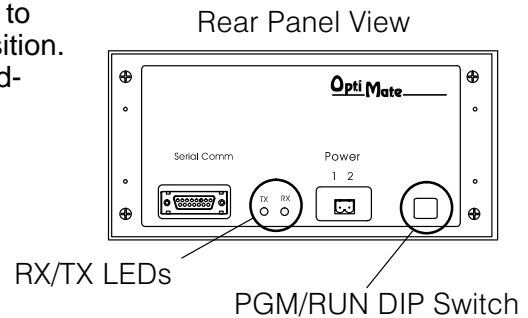
1. Observe the TX and RX LEDs on the rear of the panel. Both LEDs should be a steady flash or glow (depending on baud rate). If not, check and make sure you are using the proper communications cable and that it is securely connected.
2. Examine the PGM/RUN DIP switch to make sure it is placed in the RUN position. You must cycle OP-panel power for address switch changes to take effect.

Place the PGM/RUN switch in the RUN position when running the program.
